Wilson Lake Watershed Survey Report 2022

Acton Wakefield Watersheds Alliance

Wilson Lake Association

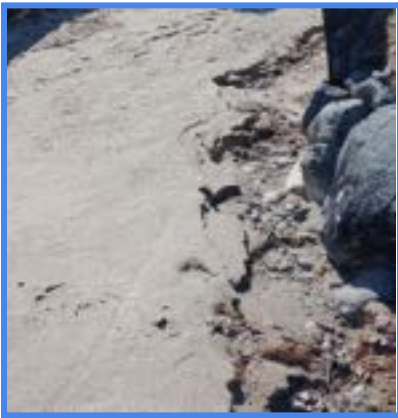
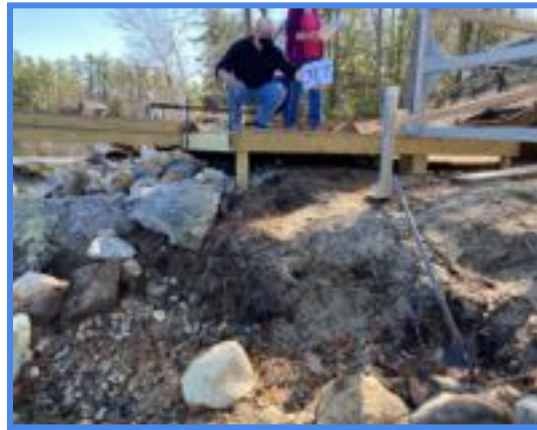
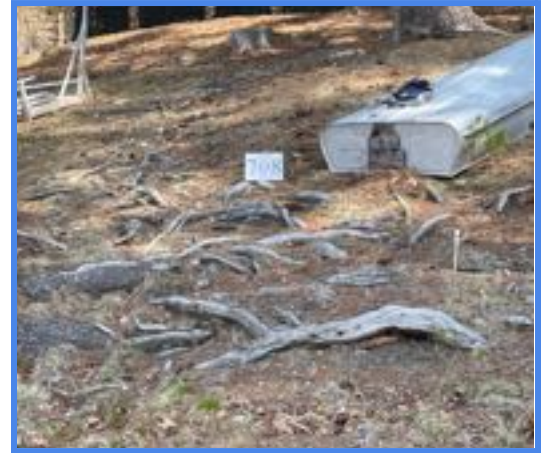
Gully Erosion - forms when fast moving water forms a channel on bare soil and begins to pick up and transport sediment downhill to the lake. Most visually obvious form of erosion. Smaller gullies are referred to as rills.

Shoreline Erosion - Shoreline can erode both from stormwater runoff and intense wind and wave action. The root systems of plants on the shoreline work to stabilize soil on the slope and protect it from eroding. In the absence of permanent, woody vegetation, the bank soils have no structure and can easily erode into the lake.

Sheet Erosion - Less apparent than a gully. Occurs when soil erodes in equal amounts across the landscape and the soil level lowers. Exposed roots are evidence of this. Roots naturally grow underground, so the amount of soil loss equals at least the height of the exposed roots. Sheet erosion often goes unnoticed and can lead to significant soil loss.

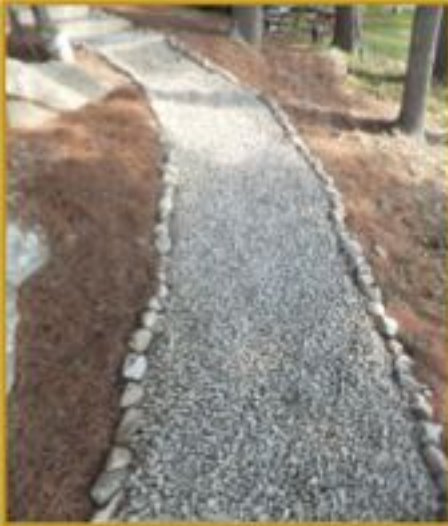
Infiltration Path - a trench filled with crushed stone that traps stormwater. Can replace dirt paths susceptible to runoff.

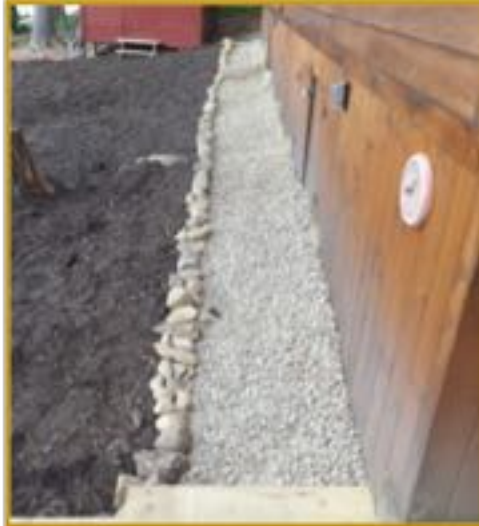
Dripline Trench - Traps roof runoff and directs it into the ground. An alternative to gutters.

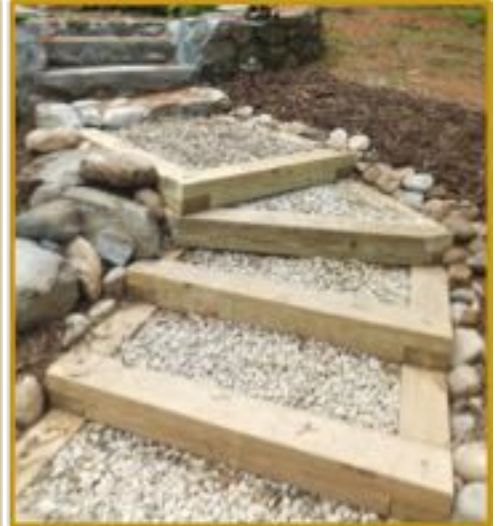
Infiltration Steps - Crushed stone steps that trap stormwater instead of allowing it to flow downhill.

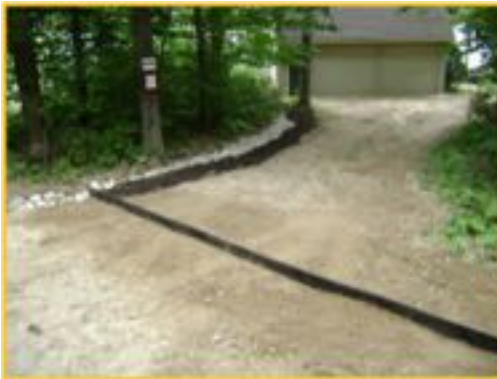
Rubber Razor - strips of hard rubber are partially buried in the driveway, placed on an angle to divert stormwater into an adjacent trench or natural area.

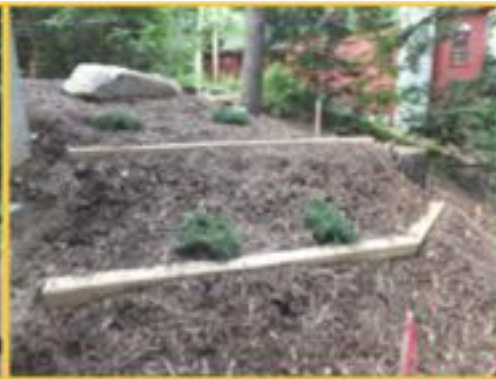
Water Bars - 6"x 6" lumber is installed on a slope with crushed stone on the uphill side to trap and divert stormwater. Water bars are left slightly raised to slow water down and can be used as seen above, or placed in a pathway in shorter lengths to function as steps.

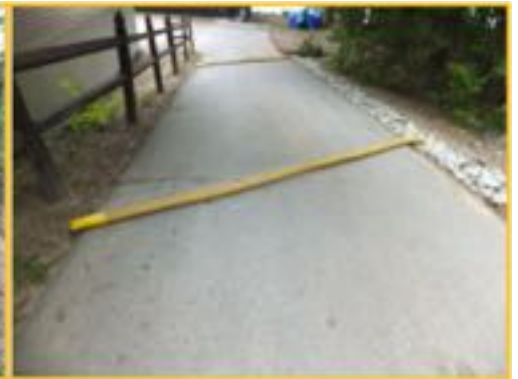
Firehose Diverter - In paved driveways, burying rubber and wood are not an option. Old firehose, or other durable material, can be filled with sand or stone and placed on an angle to divert stormwater. These have the added benefit of being movable.

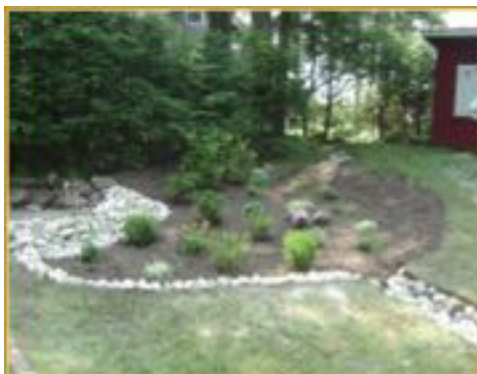
Rain Garden - pervious detention basin designed to store stormwater during a rain event and allow it to infiltrate. Typically a trench directs water into the rain garden. Water tolerant plants are put in to uptake additional water and absorb excess nutrients.

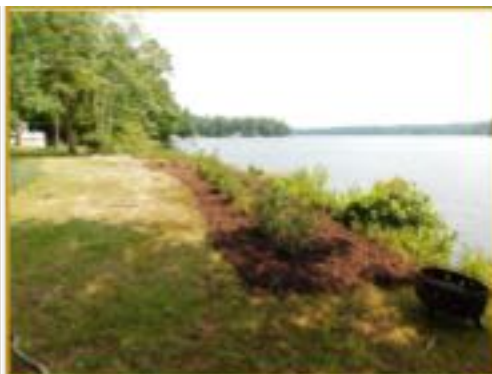
Vegetated Buffer - The shoreline is the last line of defense from stormwater. Dense, woody vegetation slows down stormwater and the root system binds sediment together and keeps it from eroding.

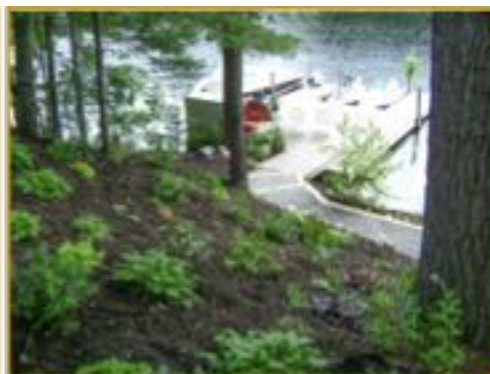
Erosion Control Mulch - This chunky mulch is made of tree and stump grindings of various sizes, this allows it to bind together and trap stormwater without washing away. This is the simplest way to protect bare soil and will last for many years before breaking down.

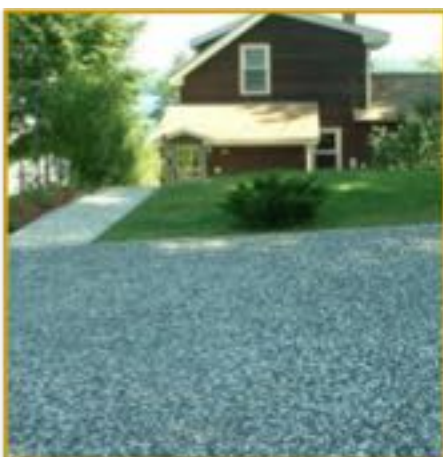
Hard Pack - This is an aggregate stone material that does not wash away as easily as sand and gravel. The lack of fine materials means less sediment erosion.

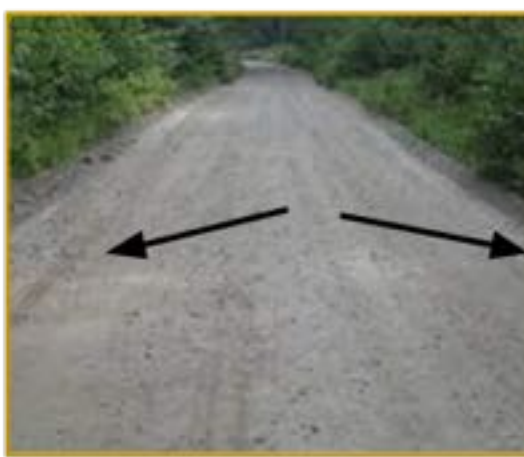
Crowning - A dirt road must be slightly pitched so water will run off of it instead of forming potholes and gullies. The high point can be in the middle to direct water in both directions, or on a far side to direct all water in one direction.

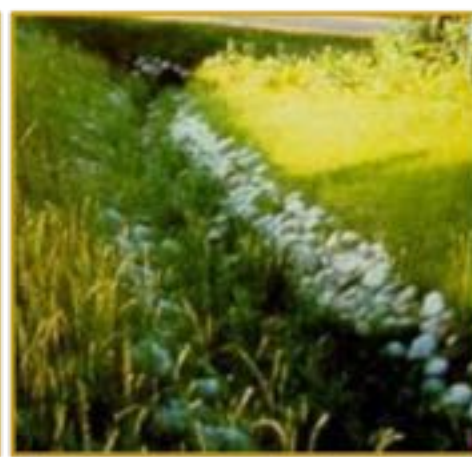
Ditching - Once water is directed off the road, it should flow into a pervious ditch to allow it to infiltrate. There are various methods such as vegetation and check dams which can be used to slow stormwater down in a ditch.

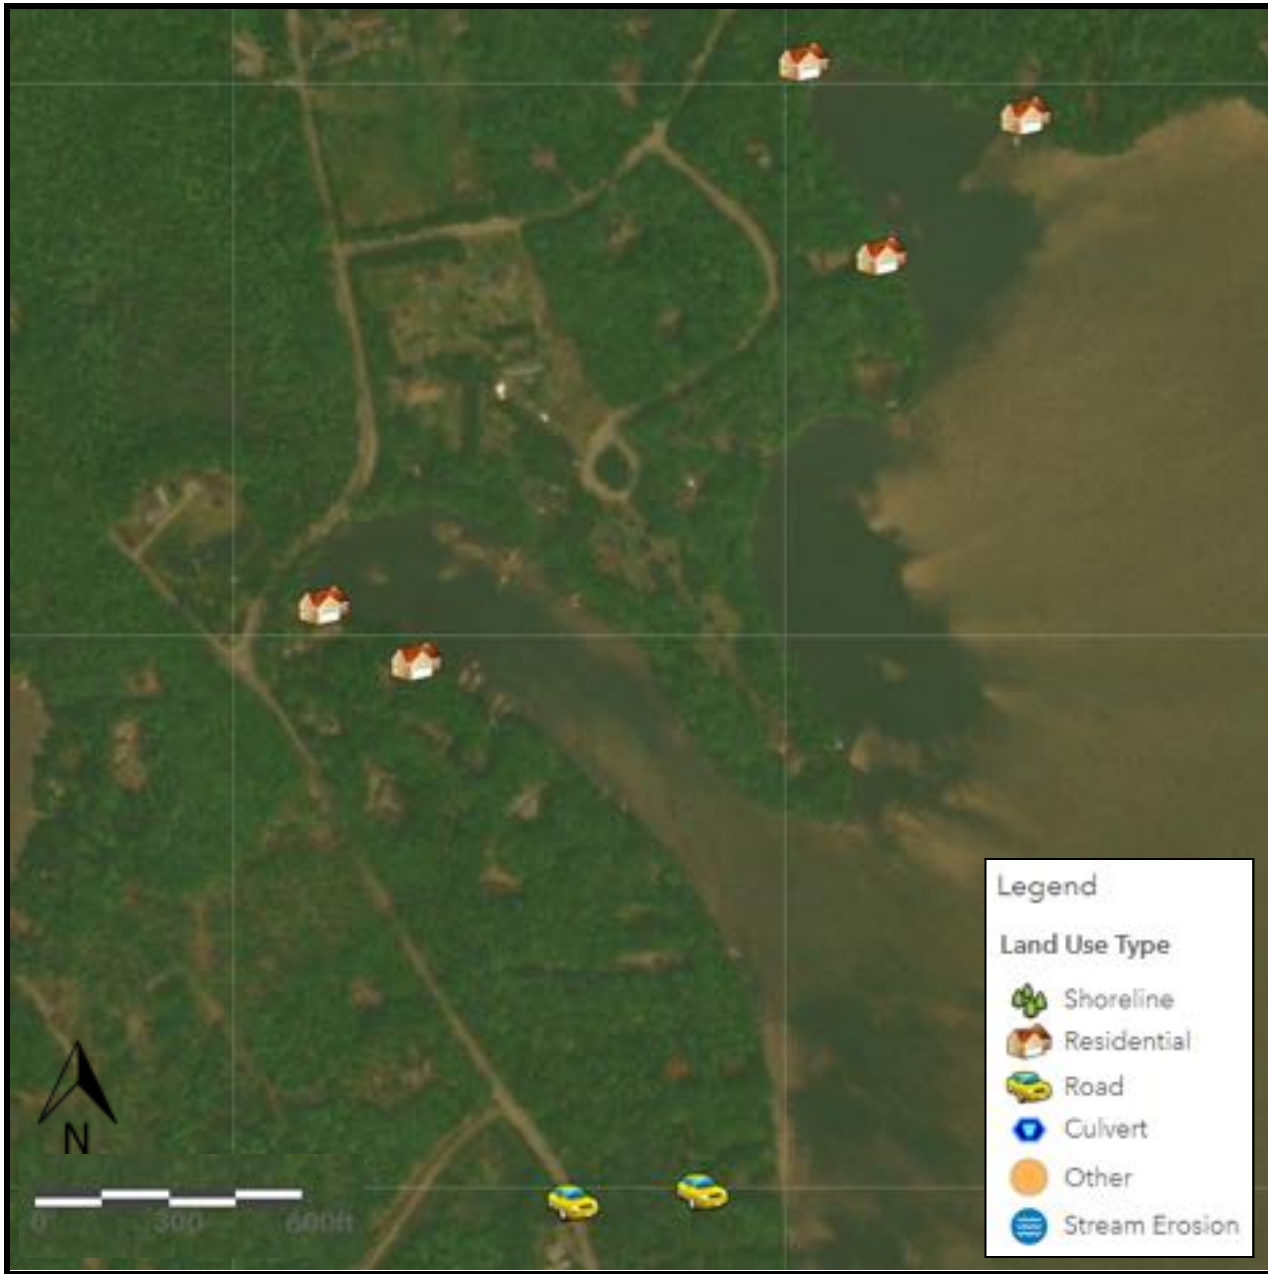
Wilson Lake - West

A description of sites and associated rankings are discussed in the next section of this report. Maps of the erosion sites are located in Appendix A, and a spreadsheet with data from the documented sites is located in Appendix B. **Contact WLA or AWWA for additional site information or to find out if a site number corresponds with your property (contact info found on page 30).**
